Muchakinock Creek

Improving water quality for the future

**A publication of the
Iowa Department of
Natural Resources
2005**

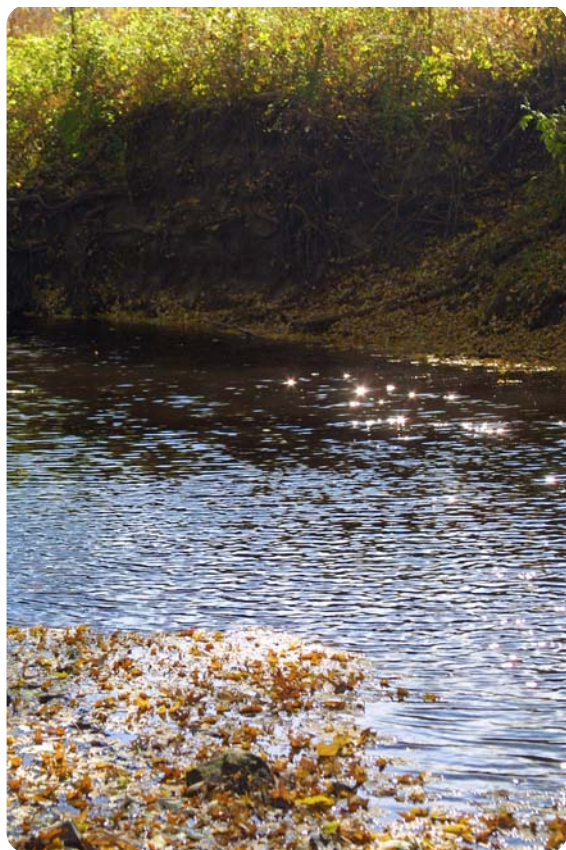
Streambank erosion sends sediment into Muchakinock Creek.

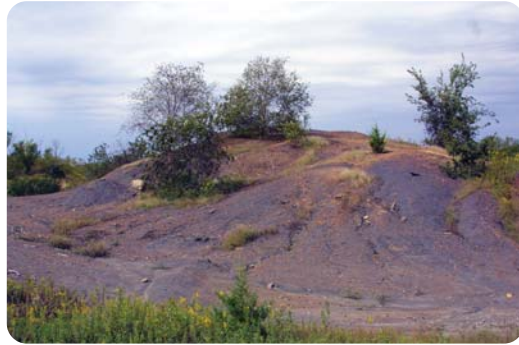
A former mining site, located south of Oskaloosa in the Muchakinock watershed. Sediment and acid drainage from abandoned mines hurt the creek's water quality.

Acid drainage and sediment from the mines continue to pollute Muchakinock Creek today. Two former mine sites cover 135 acres and send an estimated 6,300 tons of sediment to the stream every year. Another 90-acre site delivers an estimated 2,800 tons of sediment annually. These three sites are located within two miles of the creek and all have tributaries of the creek running through them.

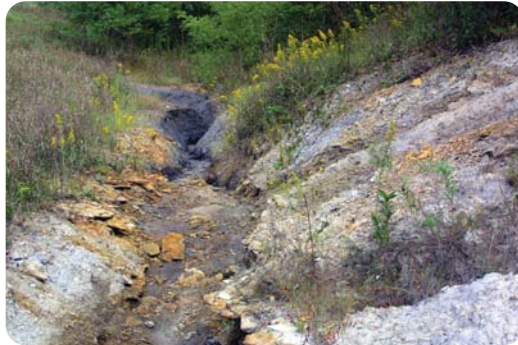
A former mining site north of Eddyville sends sediment and shale into Muchakinock Creek.

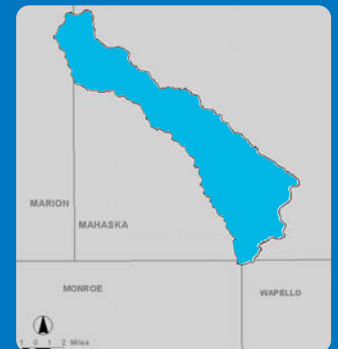
This map shows where the Muchakinock Creek watershed lies in the Mahaska County area of southeast Iowa.

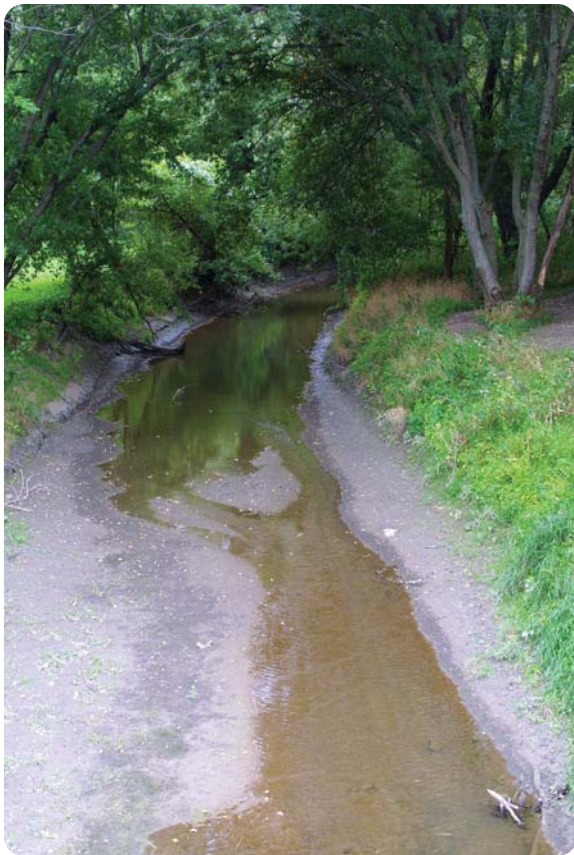
Sediment fills in the streambed of Muchakinock Creek. Erosion throughout the watershed sends excess sediment to the creek, causing a number of problems.

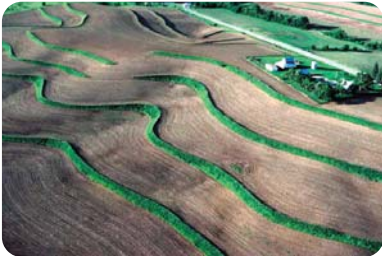
Terraces are embankments built around a hillside, usually on the contour. Terraces either slow runoff and guide it to the bottom of the hill, or collect runoff and store it until the runoff can be absorbed by the ground. Approximately 34,000 feet of terraces are planned for the Muchakinock Creek watershed.

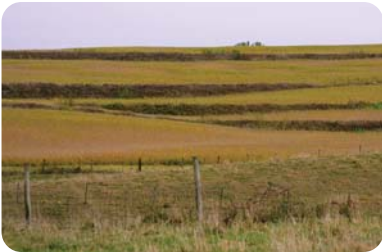
While they work in a similar way, these basins work where terraces might not. Water and sediment control basins are embankments, located in areas with concentrated runoff. The basins trap runoff water and sediment before they can reach a stream. There are 189 basins planned for the Muchakinock watershed project.

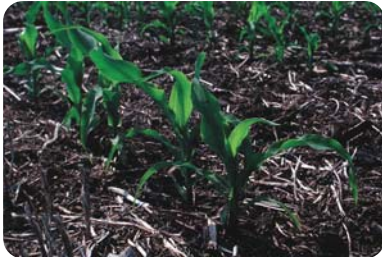
Conservation tillage uses last year's crop residue to provide ground cover, protecting against soil erosion from wind and water. Minimum tillage is already used in the watershed on some corn and soybean fields. No-till methods are used on approximately one-third of cropped fields, and soybeans currently are the preferred crop to use no-till methods on in the watershed. Conservation tillage will be encouraged along with other practices in the watershed.

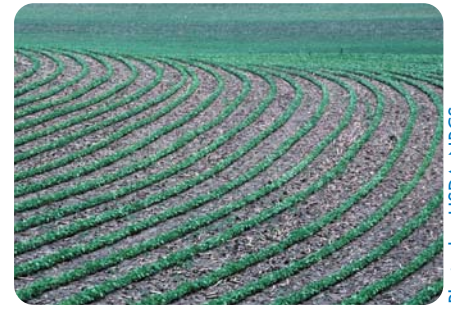
Contour farming, or planting rows around hills rather than up and down hills, reduces erosion from water runoff and conserves soil and water resources.

Farming straight up and down hills can greatly increase soil erosion, while contour farming helps reduce runoff by absorbing more water into the soil rather than allowing it to run off. Contouring prevents gullies from forming and conserves soil.

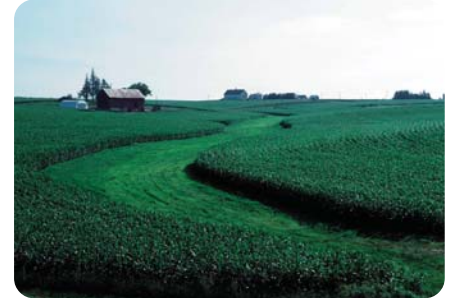
Grassed waterways are shaped and placed in areas with concentrated water flow to slow water, guide it off the field and reduce gully erosion. Grassed waterways help disperse water, preventing small streams from forming. They can also trap nutrients and sediment.

The practice can also help prevent ephemeral gulying, which is a type of erosion created by concentrated water and found in low areas between hills.

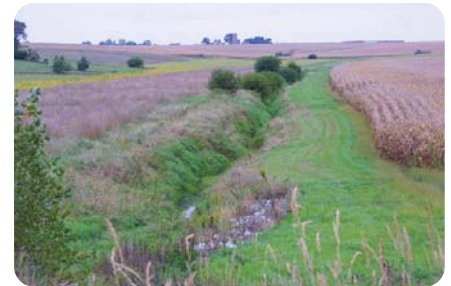
Conservation buffers slow sediment and filter runoff water before it reaches a stream. In addition, buffers reduce erosion from wind and provide habitat for wildlife. The Muchakinock Creek watershed project plans to install 120 acres of conservation buffers.

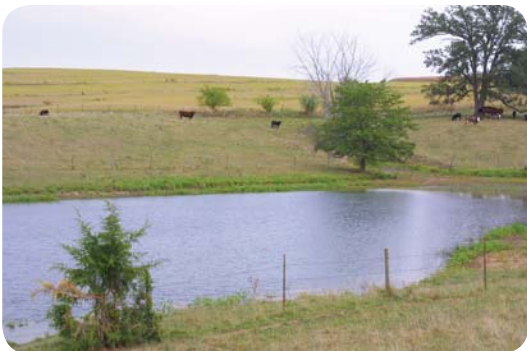
Jerry Bruxvoort's pond catches excess sediment from nearby farm fields and abandoned mines.

He's installed a buffer around the pond and would like to do mine reclama-tion work when funding becomes available.
